# Kirtland Air Force Base Bulk Fuel Facility Site

#### **Progress Report**

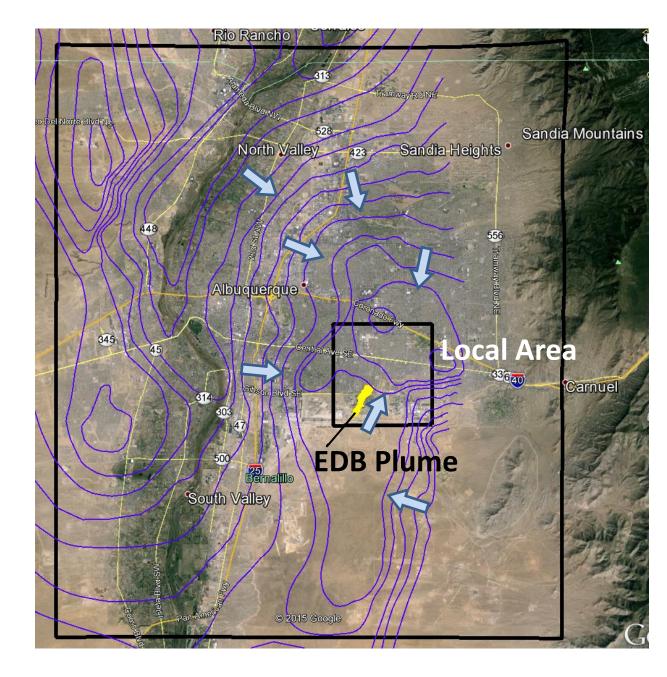
# Groundwater Flow in the Sub-Regional Metro Area

zone water level contours;
5 and 10 feet contour intervals

**Groundwater Flow Direction**

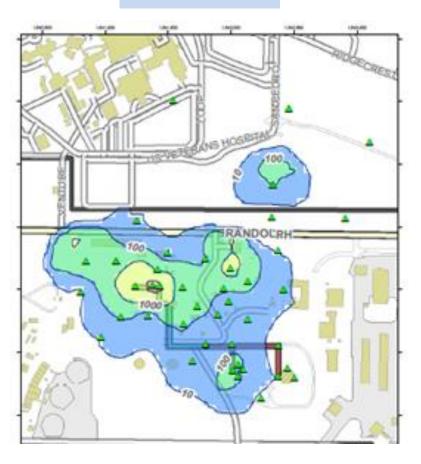
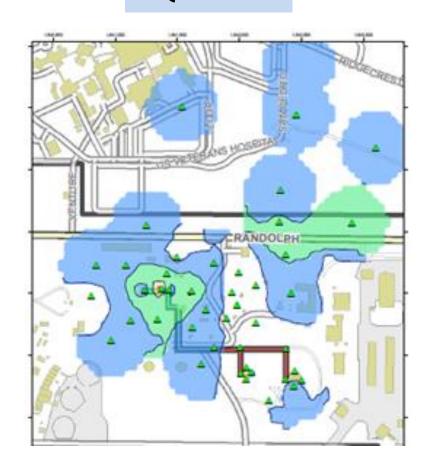
#### **Total Volatile Organic Compounds (VOC) Soil Vapor**

VOC Concentration (ppmv)
10 - 100
100 - 1000
1000 - 10,000
>10,000

150 feet below ground surface

- After 12 years of SVE operation, more than 500,000 gallons of contaminants have been removed and soil vapor concentrations have dramatically decreased
- Now is the opportune time to do rebound testing to identify remaining hot spots
- Now is also the time to do a biorespiration test to understand the contaminant degradation occurring in the vadose zone
- Now that vapors are knocked down, we are going to attack hot spots using SVE

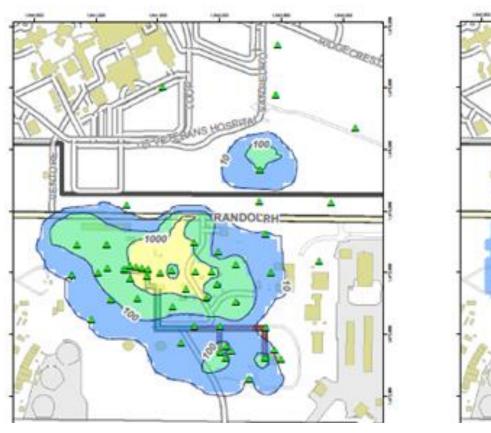
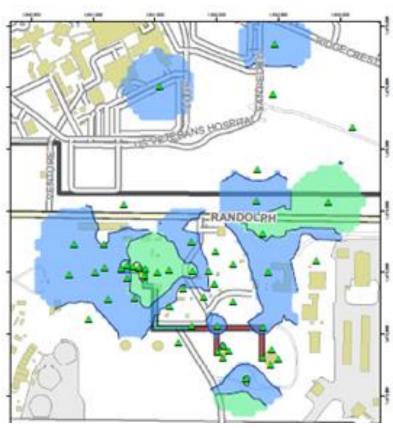
VOC Concentration (ppmv)

250 feet below ground surface

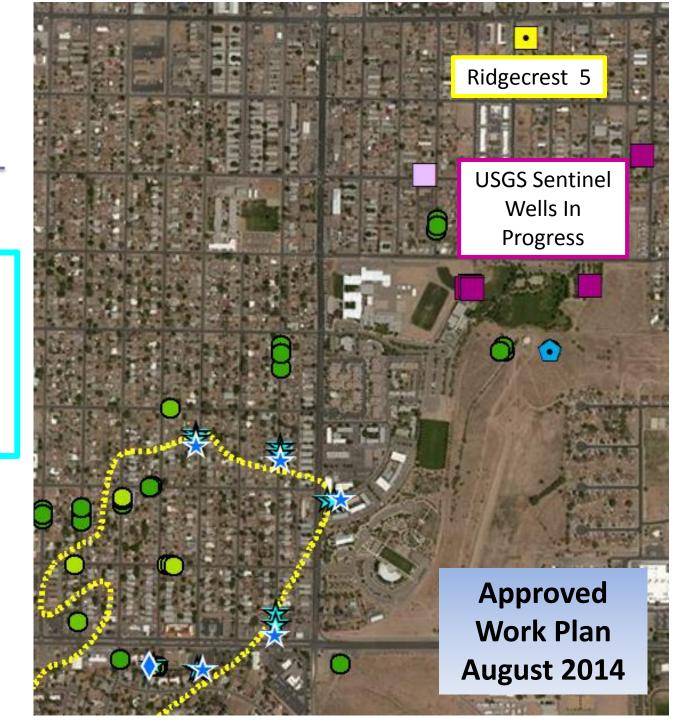
# Filling Data Gaps

Installed 11 out of 16 groundwater wells to define horizontal and vertical extent of EDB plume

#### EDB in GW ppb (Q4 2014) Result

- 0.00 ND
- 0.01 0.05 RegulatoryStd
- 0.06 1.00

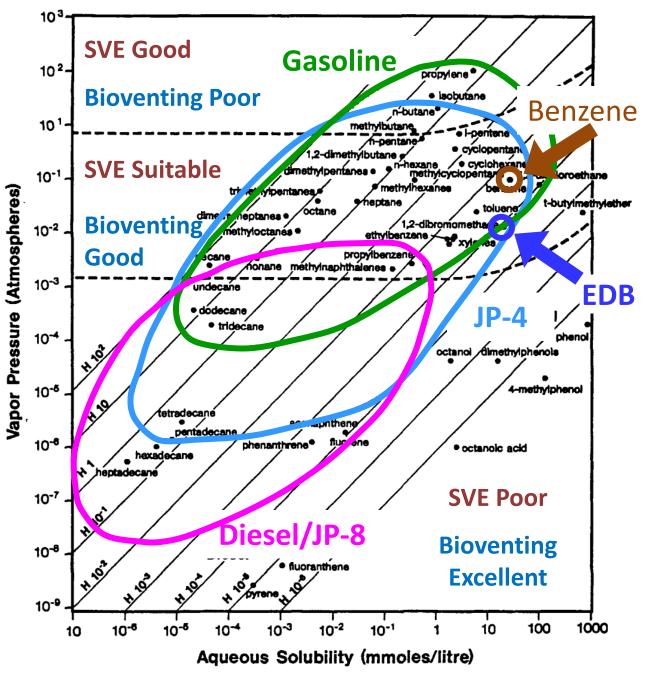
Suitability
Ranges for
SVE and
Bioventing

- Soil bacteria consume hydrocarbons with oxygen and emit carbon dioxide
- Measured oxygen, carbon dioxide, and hydrocarbon vapor will help identify:
  - Areas for continued SVE
  - Areas where treatment should switch from SVE to bioventing
  - Areas that need no further treatment
